PISCATAQUA RIVER BASIN
MILTON, NEW HAMPSHIRE

MILTON LEATHER BOARD DAM
N.H. - 00316

PHASE I INSPECTION REPORT
NATIONAL DAM INSPECTION PROGRAM

FEBRUARY 1979

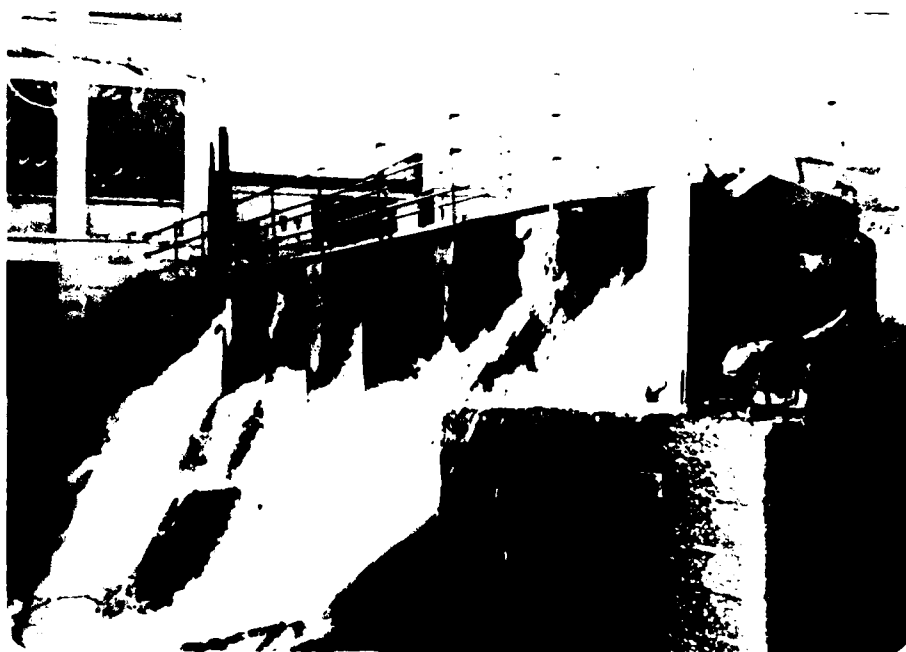
1

STOP LOG SPILLWAY

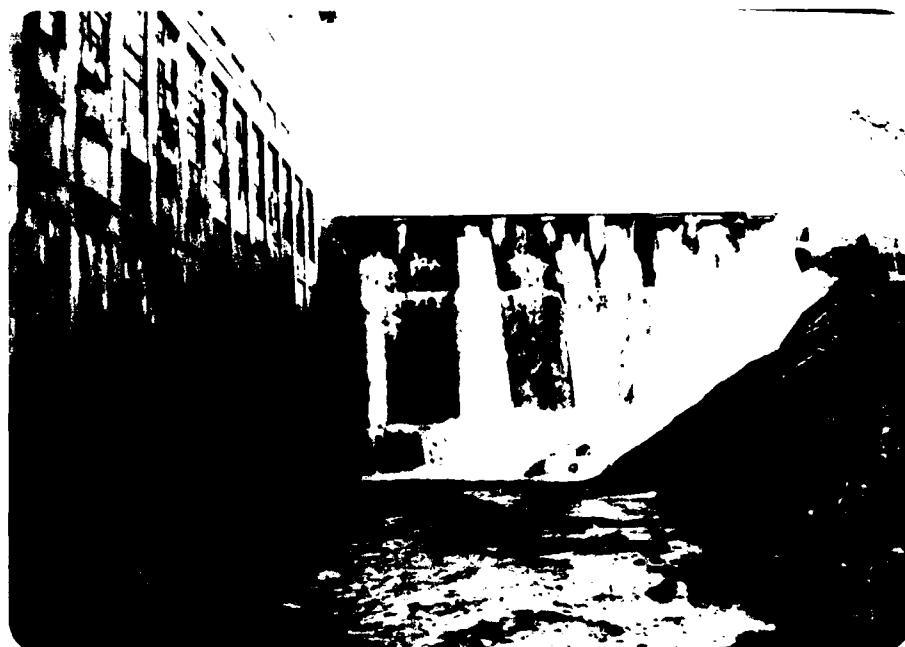
4

The stop log piers are severely spalled and eroded. The buttresses and sills beneath the piers appear to be in generally good condition with only minor concrete surface erosion.

DOWNSTREAM FACE-STOP LOG SPILLWAY

- (1) The concrete stop log piers should be repaired or replaced to prevent further deterioration of the concrete.
- (2) The concrete dike section should be rehabilitated, either by sealing of the upstream face and cleaning and filling of the voids and cracks in the downstream face or replacement.
- (3) Provide around-the-clock surveillance during periods of heavy runoff.
- (4) Develop and implement a formal warning system for use in the event of an emergency.
- (5) Provide for annual inspections of the facility by qualified engineers.

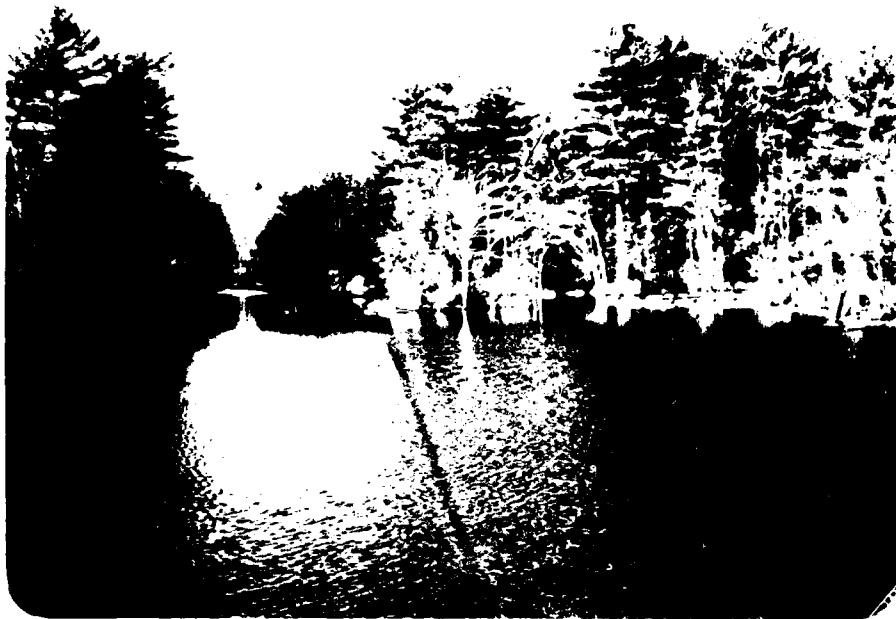
5

UPSTREAM CHANNEL
